**Field observations of debris-flow initiation processes on sediment deposits  
in a previous deep-seated landslide site**

**Keywords:** Debris flow; Initiation zone; Field monitoring; Ohya landslide

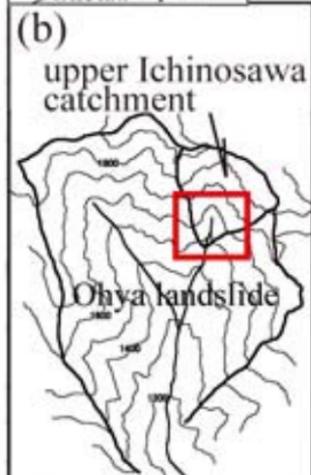
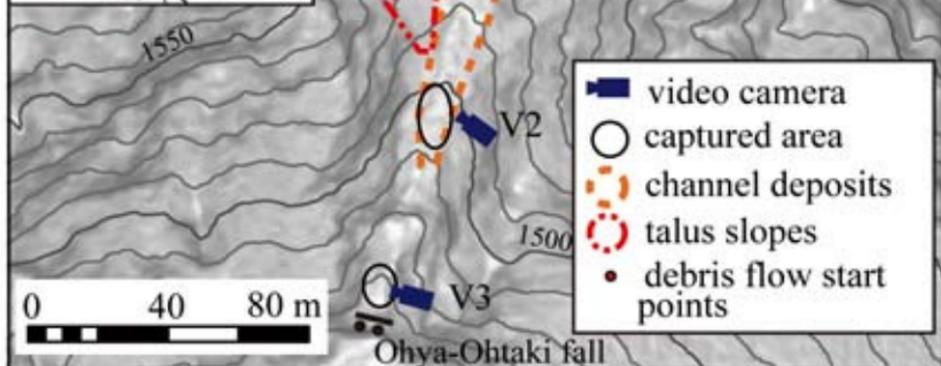
Figure 1 Location and topography of the monitoring site. (a) Location of the Ohya Landslide. (b) Location of the monitoring site in the Ohya Landslide. (c) Topographic map around the monitoring site indicating the location of monitoring instruments.

from 22° to 28° around site P1 where initiation of debris flow was observed in this study (Figure 1).

The monitoring system installed in the upper Ichinosawa catchment in early spring of 1998 includes video cameras, water pressure sensors, and a rain gauge (Imaizumi et al. 2005). In this study, we used motion images of debris flows captured by video cameras on June 19, 2012 to identify debris-flow initiation processes. Three video cameras (V1, V2, and V3) were operational in the upper Ichinosawa catchment at that time (Figures 1, 3). Locations of the video cameras were selected based on view of the channel as well as stability of the installation points. Recordings by these cameras were initiated by wire motion sensors installed at several cross sections of the channel. However, V3 did not successfully record debris flow images because of a fault in the video monitoring system. Therefore, we analyzed only video images recorded by V1 and V2. V1 was located in the debris-flow initiation zone, and recorded images of channel deposits P1 and talus cone P2 (Figure 4). V2 was located in the channel section where debris flow was initiated in the upstream pass. Bedrock was always exposed around the channel section around V3. Therefore, V3 was located in a transportation zone of debris flows.

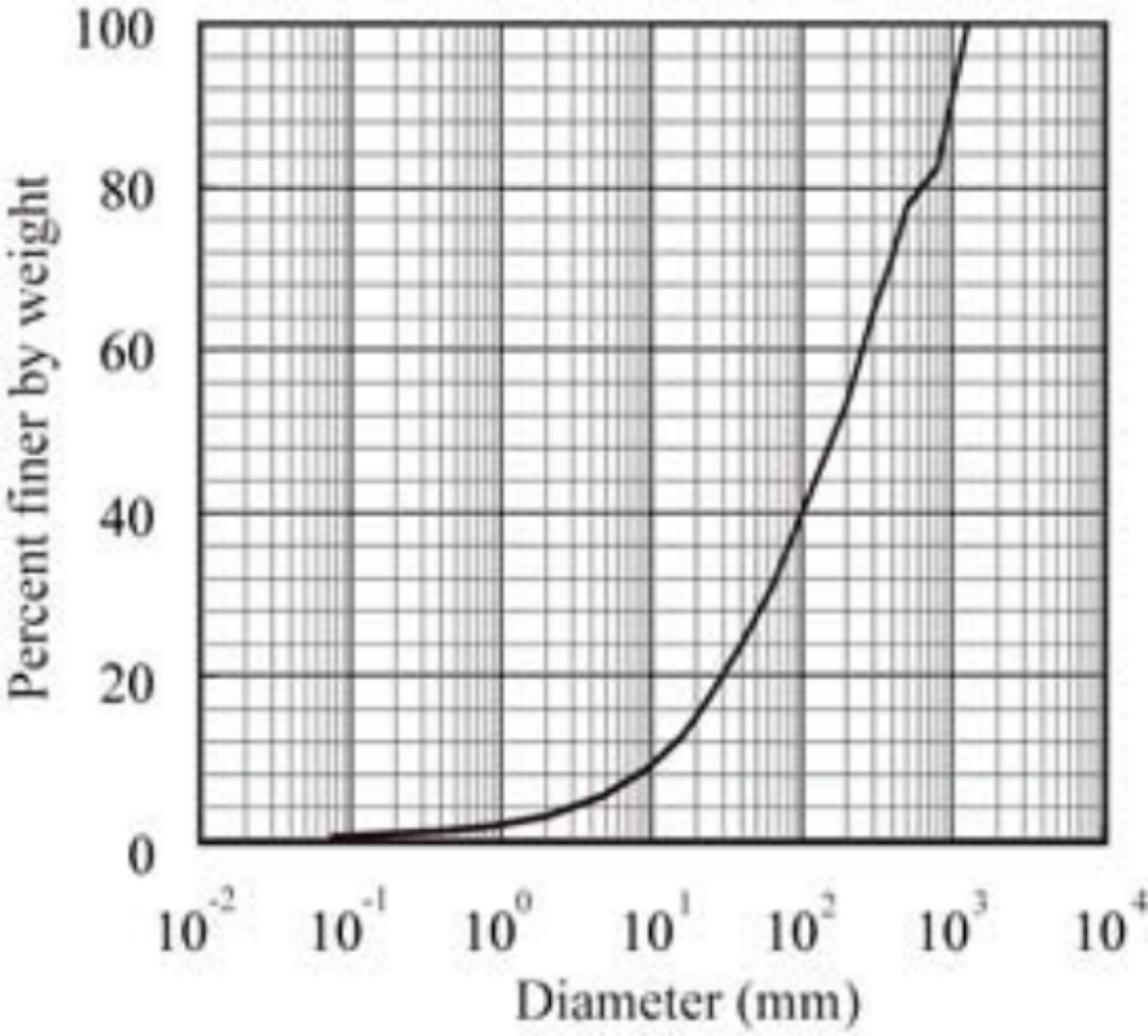
Figure 2 Grain size distribution of channel deposits.

Unstable materials have subsequently been supplied to the channel, and have affected the occurrence of debris flows since the original failure (Tsuchiya and Imaizumi 2010). The most active sediment supply process in the upper Ichinosawa catchment is freeze-thaw weathering, which promotes dry ravel in winter (Imaizumi et al. 2006). Sediment produced by freeze-thaw is rapidly transported into the channel and to the talus slopes. As a result of the active sediment supply in winter, sand to boulder-sized unconsolidated debris has accumulated on the channel bed and talus slopes (Figure 1). The thickness of debris deposits exceeds several meters in some sections. The grain size of fine channel deposits (diameter < 100 mm) sampled at three locations around P1 was analyzed in the laboratory using sieves with mesh sizes of 0.075, 0.106, 0.25, 0.425, 0.85, 2.00, 4.75, 9.50, 16.0, 19.0, 25.4, 31.7, and 63.5 mm. Since it is hard to sieve coarse channel deposits (diameter > 100 mm), we measured their grain size by the line grid method with interval of 1 m in the field. Komura and Ozawa (1970) proposed a method estimating grain size distribution in weight from the line grid method; average of the size distribution in number and the size distribution in weight, which is estimated from the grain size measured by the line grid method and the bulk density of sediment, roughly corresponds to the grain size distribution in weight analyzed by sieves. Therefore, we estimated the grain size distribution of coarse channel deposits (diameter > 100 mm) in weight by the method of Komura (1970) under assumption that the bulk density of sediment is 2650 kg m<sup>-3</sup>. Grain size distribution for the entire grain size was estimated from the size distributions of fine and coarse sediment as well as volumetric fraction of fine sediment in the channel deposits investigated in site (Figure 2). Cobbles and boulders (diameter > 64 mm) occupy about 70% of the entire channel deposits in the Ohya landslide. In addition, sediment finer than silt (diameter < 8 mm) is less than 9% of the entire channel deposits. Thus, channel deposits in the Ohya landslide is characterized by its large grain size and a small fraction fine sediment. Large boulders (> 1 m) are also commonly found in the channel deposits by the field survey.

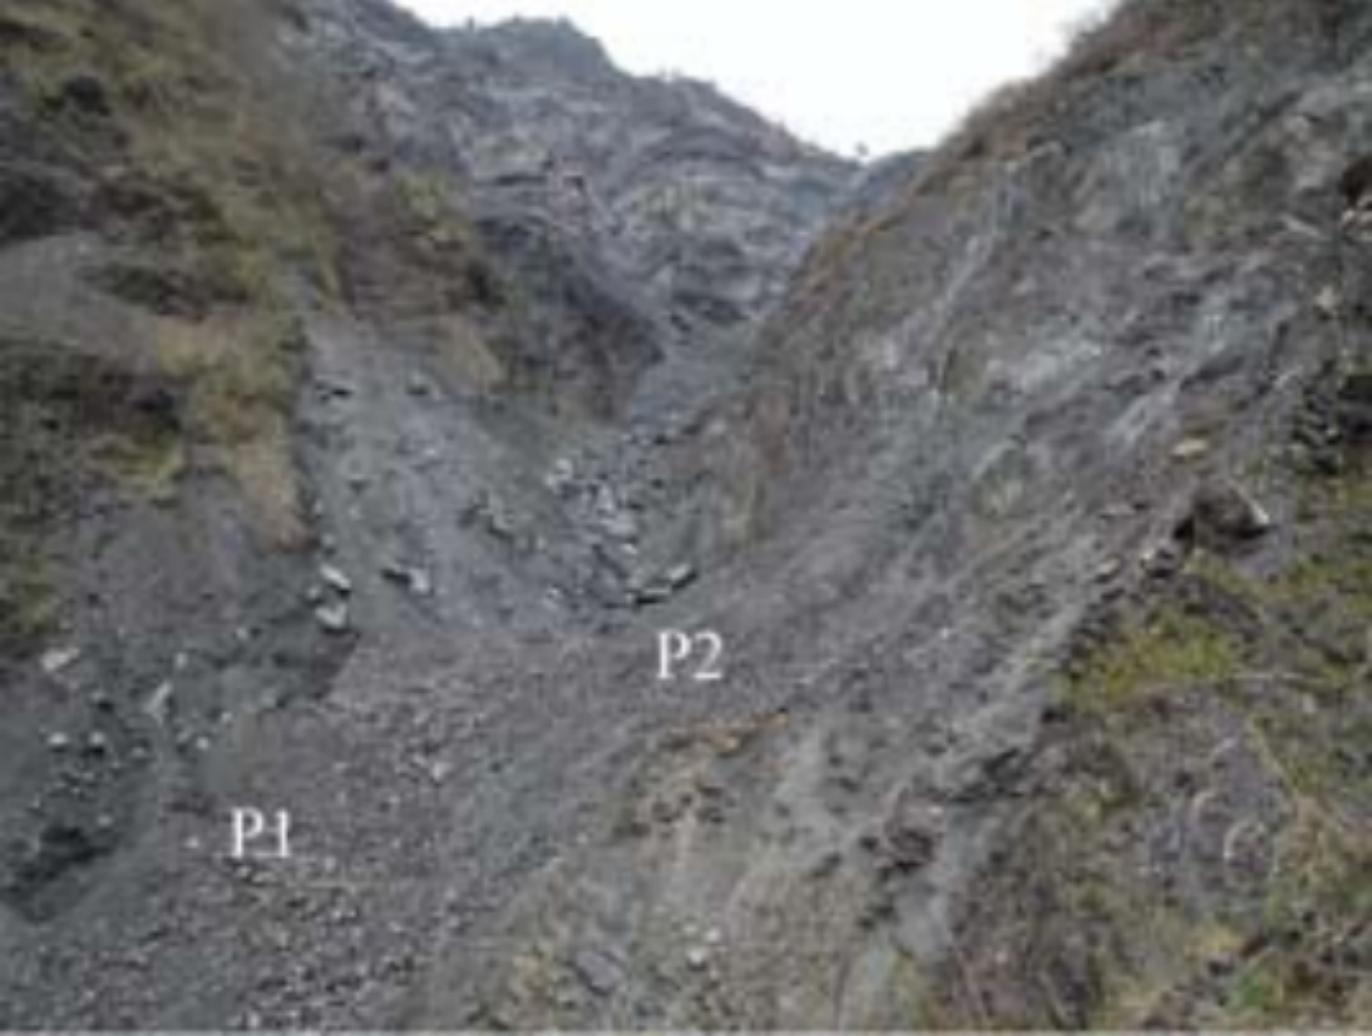
Figure 4 View of the channel deposits at P1 and the talus slope at P2 taken on May 14, 2012.

P1

P2

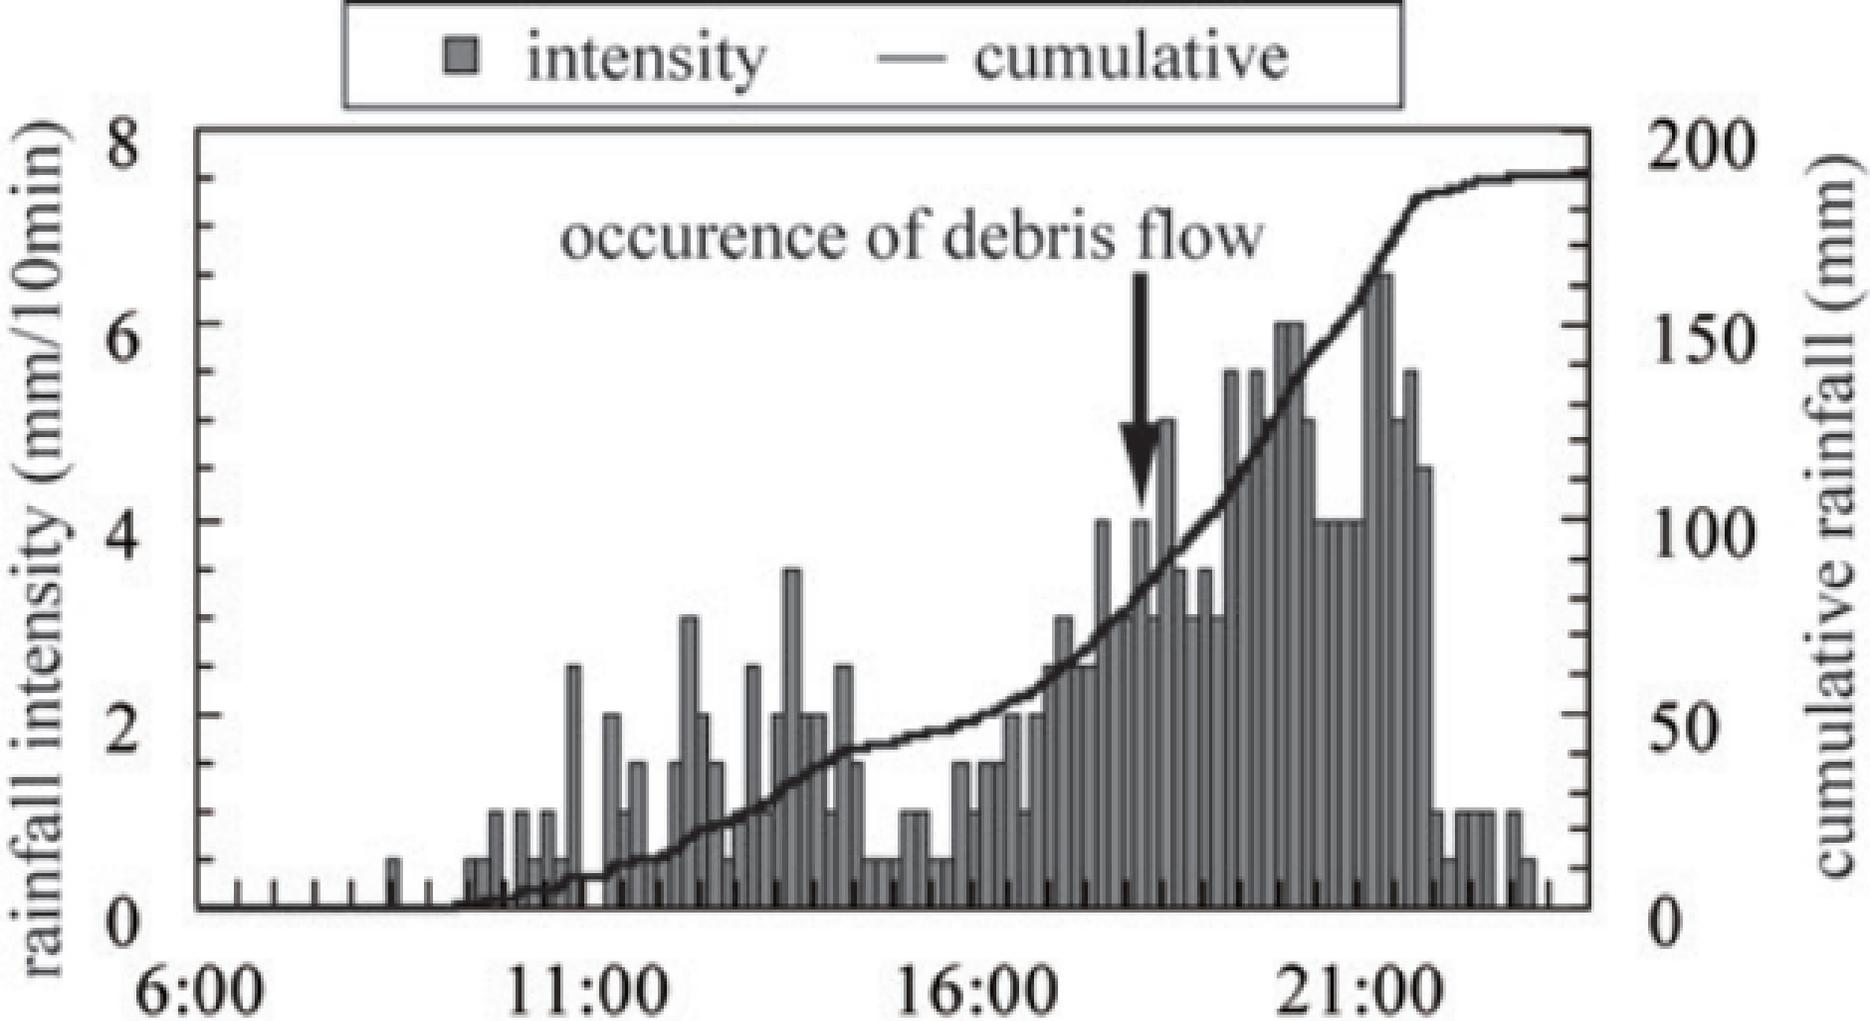
Figure 5 Precipitation during the rainfall event that triggered the debris flow on June 19, 2012.

Total rainfall and maximum hourly rainfall observed by the rain gauge close to V1 during the June 19 event were 189 mm and 29.5 mm, respectively. The cumulative rainfall at 18:16, when the occurrence of the debris flow was first identified on the video camera image, was 82.5 mm (Figure 5). Debris flow

occurred just after a small rainfall intensity peak with a maximum 10-min rainfall of 4.5 mm ( $27 \text{ mm h}^{-1}$ , 18:03-18:13). Imaizumi et al. (2002) defined the critical rainfall condition for debris flow initiation in upper Ichinosawa catchment to be a maximum 10-min rainfall of 5 mm ( $30 \text{ mm h}^{-1}$ ) and cumulative rainfall of 30 mm. Although the cumulative rainfall before the debris flow on June 19 exceeded this critical condition, the 10-min intensity was slightly below the critical level.

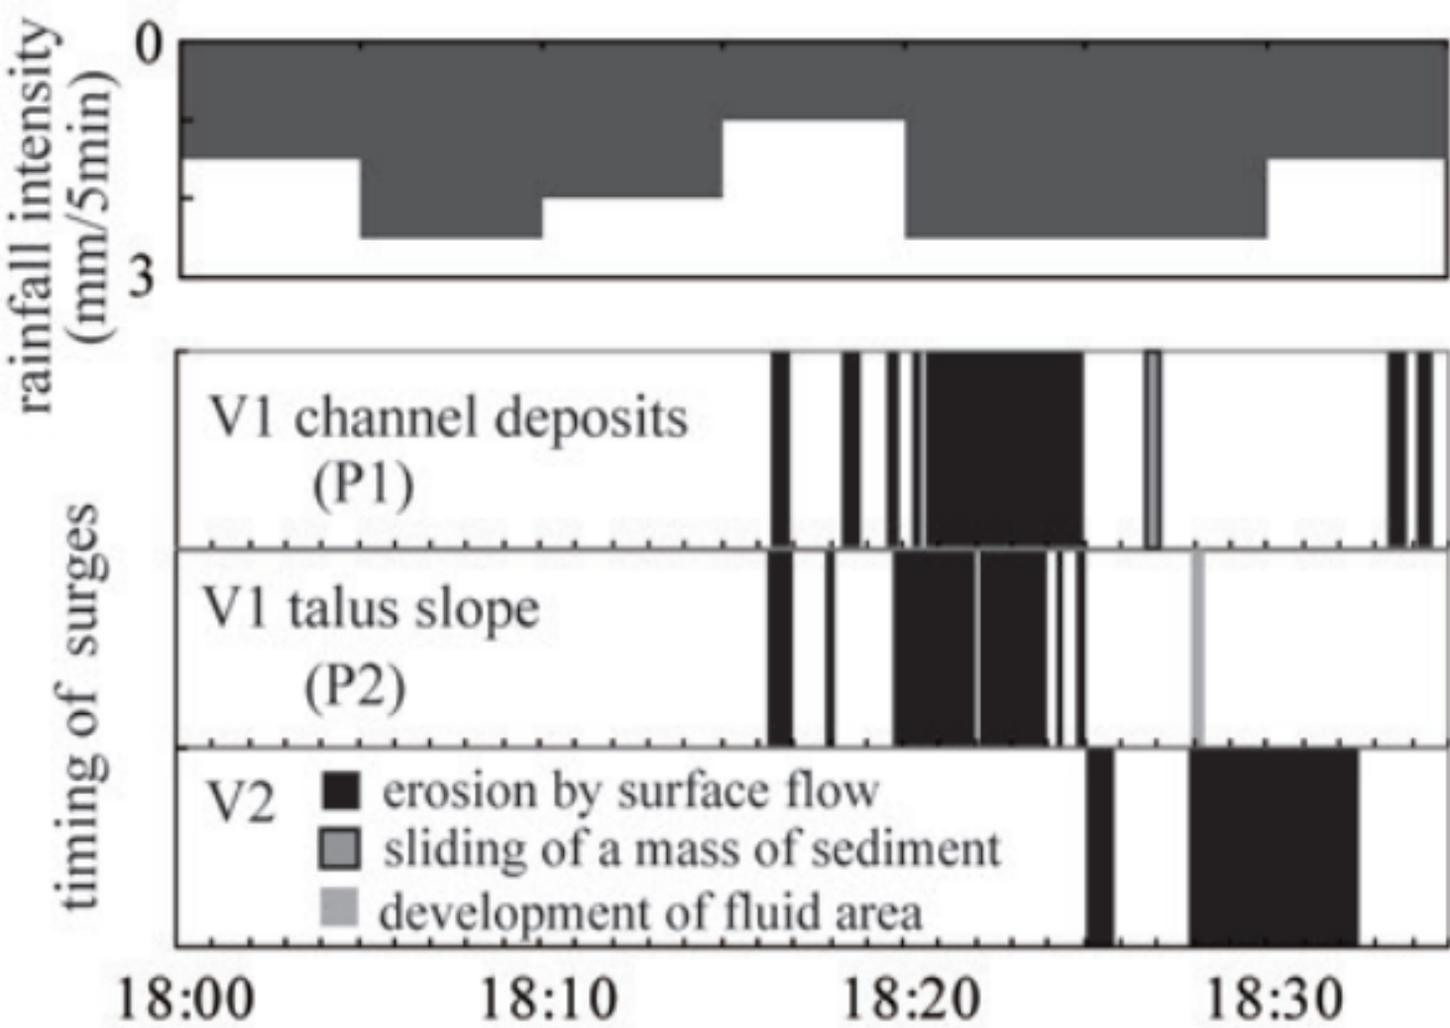
Figure 6 Timing of the debris-flow surges during the event on June 19, 2012.

The analysis of video images revealed that deposits started to move repeatedly during the debris flow event on June 19, 2012 (Figures 6, 7). These movements of deposits differed from typical debris flow surges in two ways: pore fluid was not abundant and the grading of boulders was not clear. However, we refer to these movements as surges in this study. The initial debris-flow surges were captured by V1 at 18:16; two distinct surges occurred on channel deposit P1 and talus cone P2 at the same time (Figure 6). As with debris flows in other torrents (Liu et al. 2009; Arattano et al. 2012), the debris flow event on June 19 composed of many surges; the total numbers of surges that occurred at P1 and P2 during the June 19 event were nine and eight, respectively (Figure 6). We could not analyze debris-flow surges after 18:35 because surges were not clearly seen in the video image affected by the darkness after sunset. The water pressure sensor at V3 monitored abrupt changes in the flow height until 21:30. Therefore duration of the debris flow event is estimated to be 3 h. The timing of the occurrence of debris-flow surges at P1 did not completely agree with those at P2. However, debris-flow surges occurred frequently in the period from 18:16 to 18:25 at both locations.

Although rainfall is the trigger of debris flow in the Ohya landslide, the timing of individual debris flow surges did not clearly coincide with the temporal changes in the rainfall intensity (Figure 6). Time-lag between increases in the rainfall intensity and increases in discharge in the main channel (and increases in the water content in channel deposits), which directly cause debris flows, may affected disagreement of timings between the rainfall intensity and the occurrence of surges.

channel section upstream of V2. Because the timing of surges captured by V2 did not coincide with those captured by V1, most of the surges during this event did not travel a long distance in one movement, but migrated downstream in stages. Changes in the debris flow discharge with migration toward downward have been monitored in transportation and deposition zones in the world (e.g., Arattano et al. 2012; Navratil et al. 2013). Our monitoring results at two sites (V1 and V2) showed that such changes in the discharge occur in the short section (< 100 m) in the initiation zone of Ohya landslide (Figure 6).

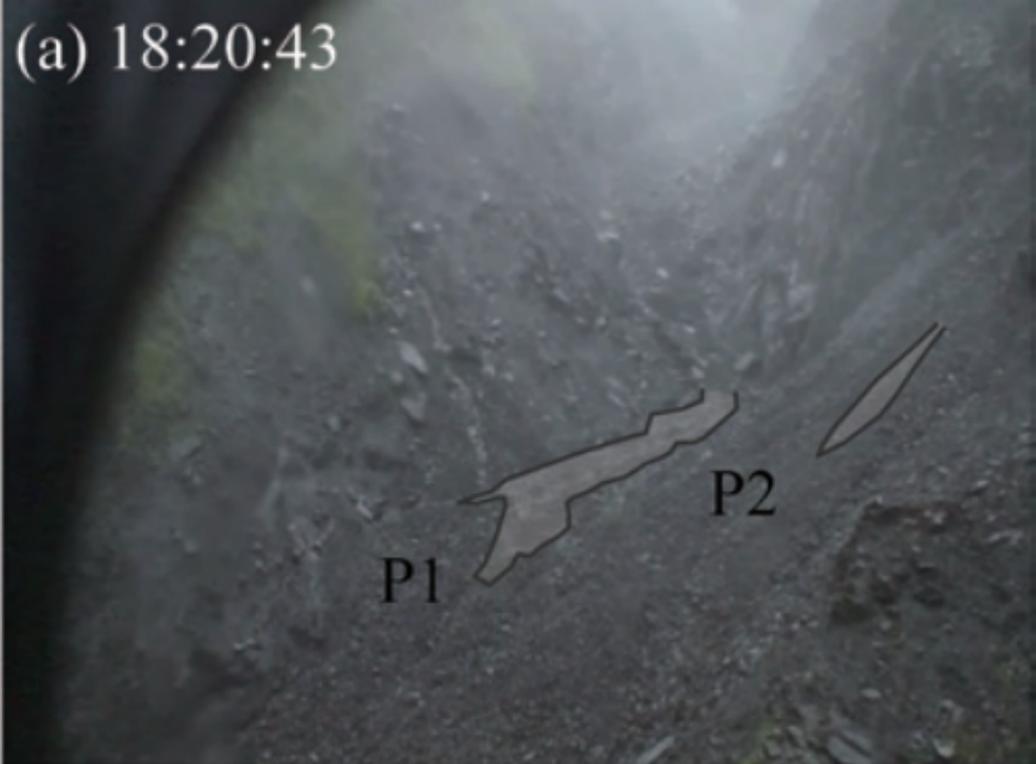
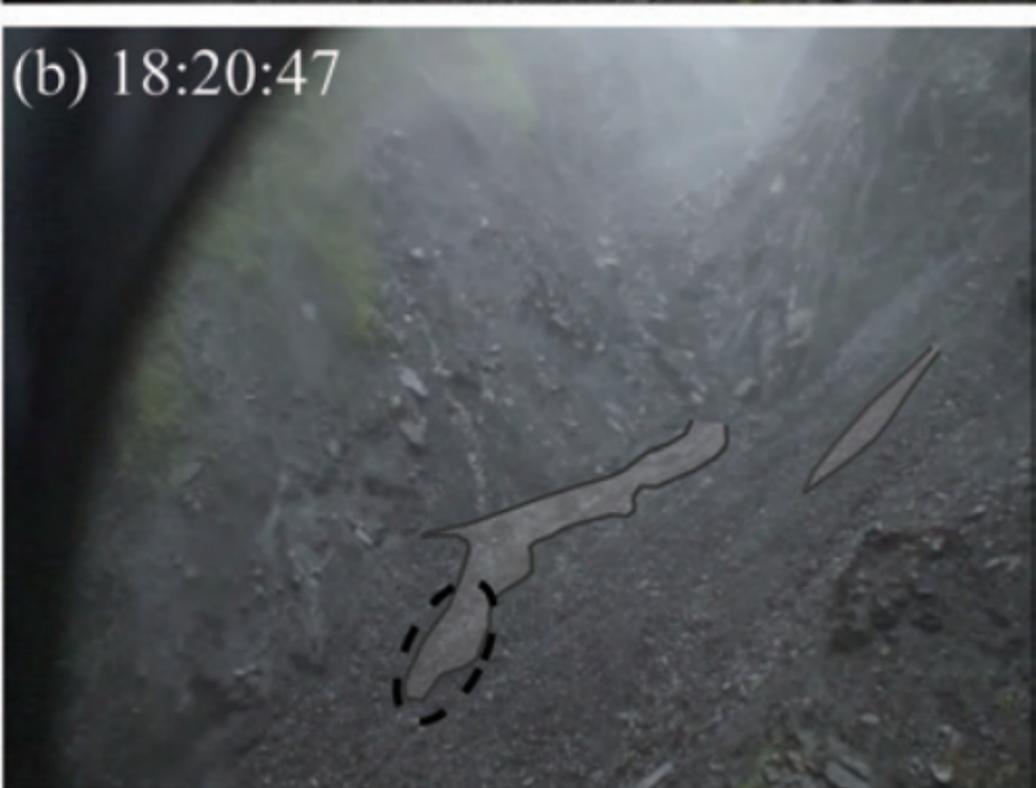
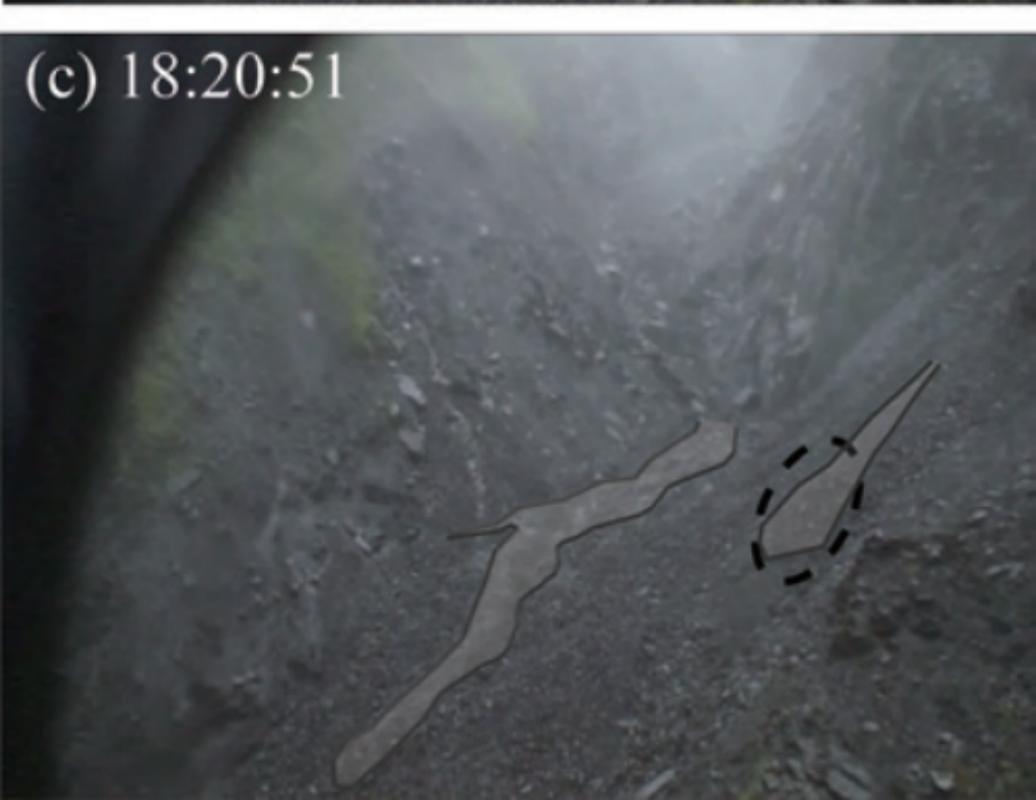
Figure 7 Video image captured by the video camera V1 at 18:20 when a debris-flow surges were initiated around point P1 and P2. (a) Image at 18:20:43 just before initiation of debris-flow surges. The white painted area indicates the existence of surface flow. (b) Image at 18:20:47 just after initiation of a debris-flow surge at point P1. The area, in which the fluidization of channel deposits started, is surrounded by a dashed line. (c) Image at 18:20:51 just after initiation of a debris-flow surge at point P2. Fluidization of deposits on talus slope started around the area surrounded by a dashed line.

(a) 18:20:43

(b) 18:20:47

(c) 18:20:51

The occurrence of most debris-flow surges was closely related to the development of surface flow on the deposits (i.e., channel deposits and a talus cone; Figure 7, 8a). Before initiation of the debris-flow surges, no surface flow existed at both P1 and P2, because all of the surface flow had infiltrated into thick deposits (depth  $> 2 \text{ m}$ ) above the two locations. Such high permeability of the channel deposits is possibly affected by the large grain size of the channel material (Figure 2). As the surface flow arriving on the deposits increased, the infiltration points of the surface flow (i.e., downstream of the surface flow) migrated downward. Eventually, surface flows started to increase their discharge by the erosion of sediment, and developed into debris-flow surges. Sediment eroded by surface flow accumulated at the front of the flow.

The mobility of most of surges observed on June 19, 2012 was low; flow velocity, estimated by the video image analysis, was low ( $< 3 \text{ m s}^{-1}$ ), and surges generally terminated within 100 m from their initiation point. The duration of each surge was typically from 10 s to 2 min. The mobility of a surge starting at 18:20 was relatively higher than other surges, with a flow velocity of  $3\text{-}5 \text{ m s}^{-1}$ . The ratio of pore fluid (muddy water) to the overall flow (sediment plus muddy water) of this surge was clearly higher than the other surges. In addition, the duration of this surge (4 min) was longer than other surges. Analysis of the video images revealed that surface flow from the upper stream continuously supplied a large volume of water during this surge.

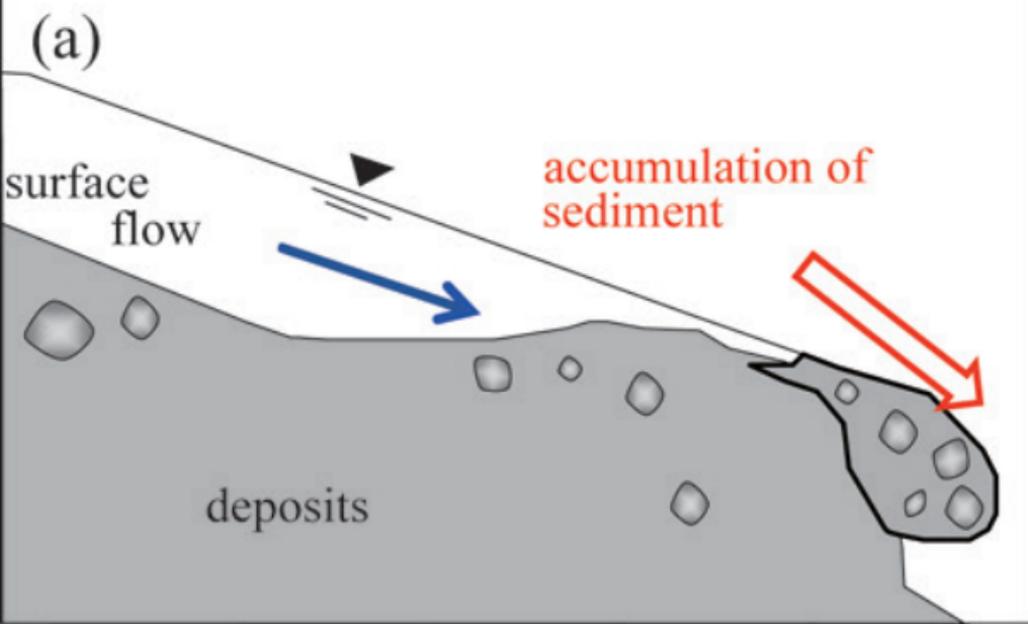
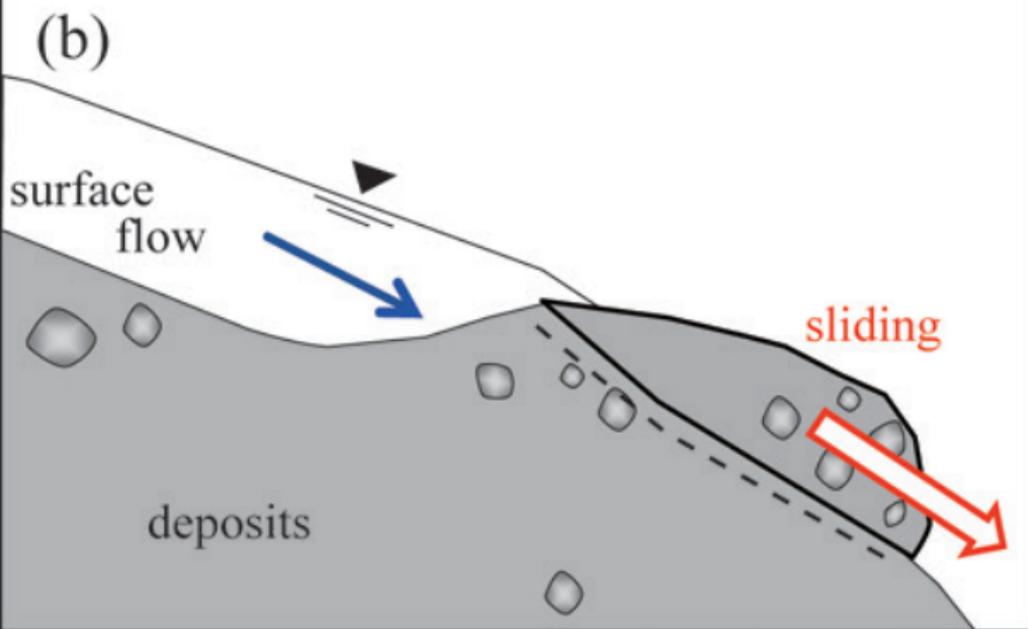
Figure 8 Schematic diagrams of the initiation mechanisms of debris-flow surges. (a) Erosion by surface flow. Sediment eroded by surface flow accumulated at the front of flow. (b) Sliding of a mass of sediment.

As a result of field monitoring using video cameras, three debris-flow initiation mechanisms were identified in the Ohya landslide. One surge was initiated by the sliding of a mass of sediment. Increases in the pore water pressure associated with rising of the groundwater table, which is a typical initiation mechanism of a landslide (e.g., Iverson 2000; Sidle and Ochiai 2006), might have triggered this type of sediment movement. Initiation mechanism of the sliding of the mass can be expressed by comparison between the shear stress and the shear strength at a sliding surface. By assuming that the pore water pressure in channel deposits is same as the hydrostatic pressure, factor of safety for movement of the mass of cohesionless sediment on an infinite slope is given as:

The other debris-flow initiation mechanism was the upward expansion of the fluid area. Movement and evacuation of sediment at the lower part of deposits by surface flow destabilized the upper part of the deposits, and facilitated the upward development of the fluid area. Previous monitoring-based studies have reported that surface flow affects the occurrence of debris flows (e.g., Suwa et al. 1989; Takahashi 1991; Berti et al. 1999; Okano et al. 2012). Although roles of the surface flow on initiation of debris flow surges were different among three initiation mechanism (water supply facilitating rising in groundwater table, erosion of sediment, and destabilization of the deposits), increasing in the surface flow was the triggering factor in all three mechanisms.
