Spatiotemporal damages on an endangered endemic aquatic plant, *Schoenoplectus gemmifer* (Cyperaceae), by a series of heavy floods

Koshi Kitamura<sup>1</sup>, Jin Yoshimura<sup>1, 2, 3\*</sup>, Kei-ichi Tainaka<sup>1</sup> and Satoshi Yokojima<sup>1</sup>

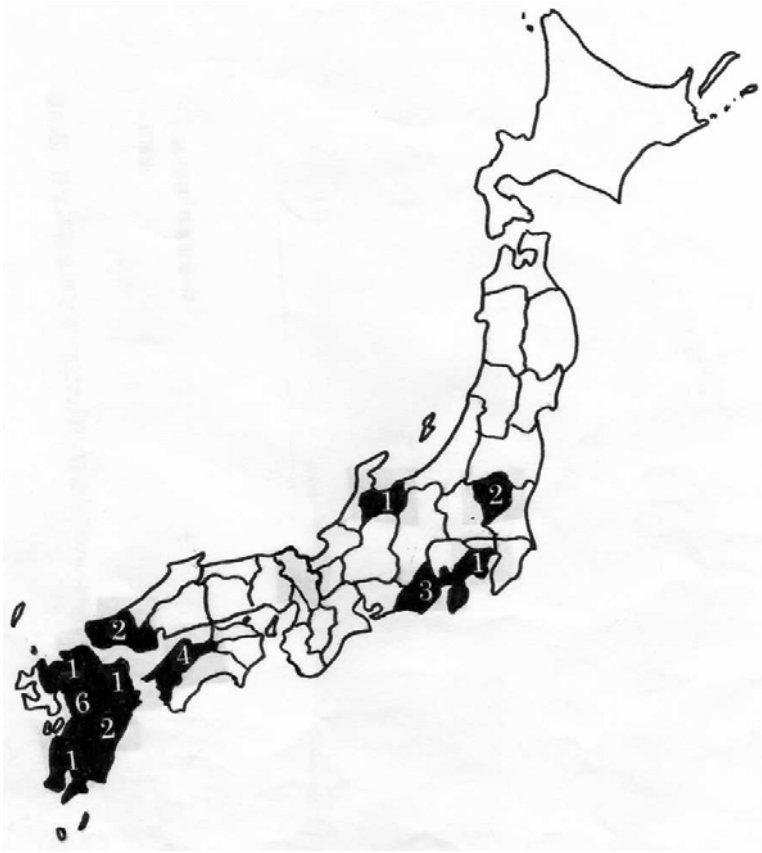
Fig. 1

The currently known distribution of *S. gemmifer* is limited only about 20 locations in Japan, including some extinct localities (Fig. 1 and Table 1). The distribution of the species is highly sparse and scattered mainly in the western half of Japan (Fig. 1). The only exception is Kumamoto Prefecture, which has at least 6 identified locations.

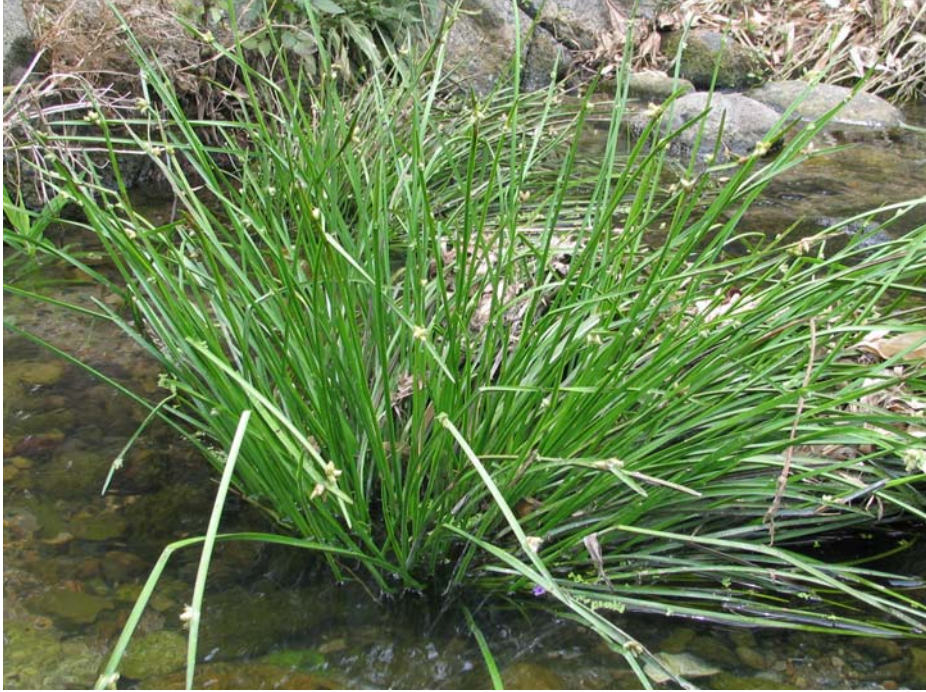
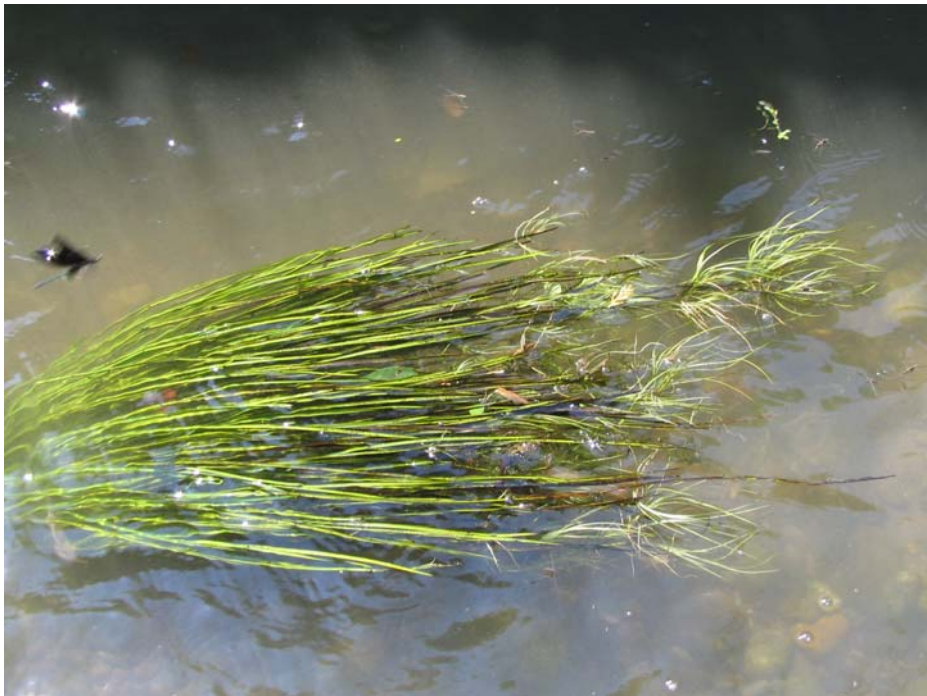
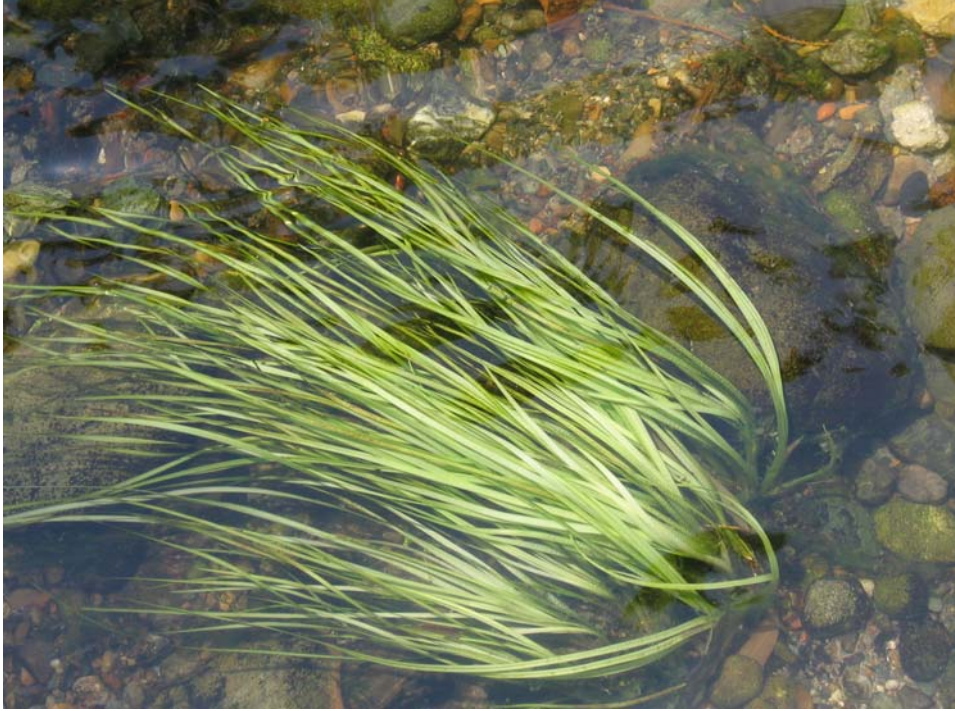
Plate 1

*triangulatus*. The two main features of *S. gemmifer* are (1) linear leaf blades (Plate 1C) and (2) gemmae (budding or vegetative form of reproduction; Plate 1B).

Linear leaf blades are the stream-form culms, while the usual still water-form stems are triangular culms. *S. triangulates* has only triangular culms which mostly stand out of water surfaces. A stock of *S. gemmifer* sometimes develops a few linear leaf blades. We also found many stocks mostly or entirely consisting of linear leaf blades after the severe floods (Plate 1C).

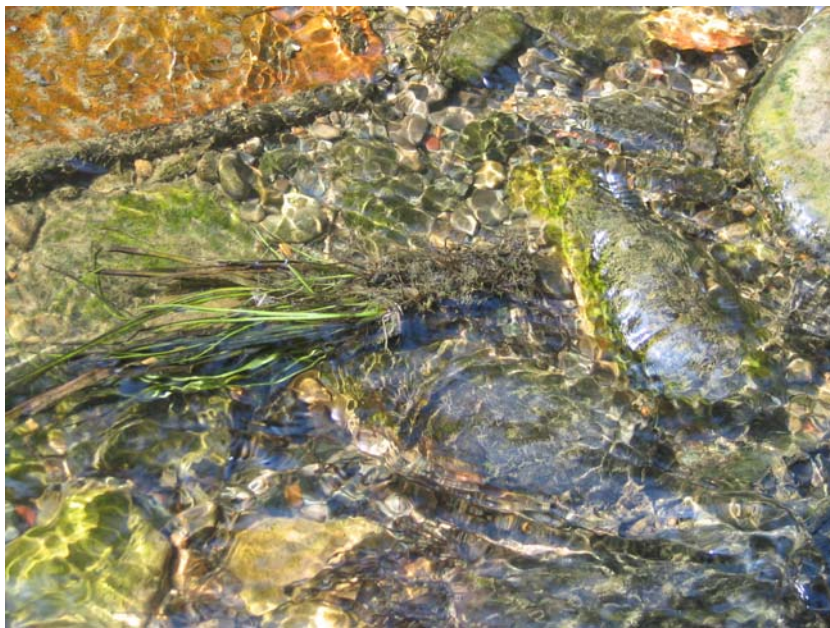
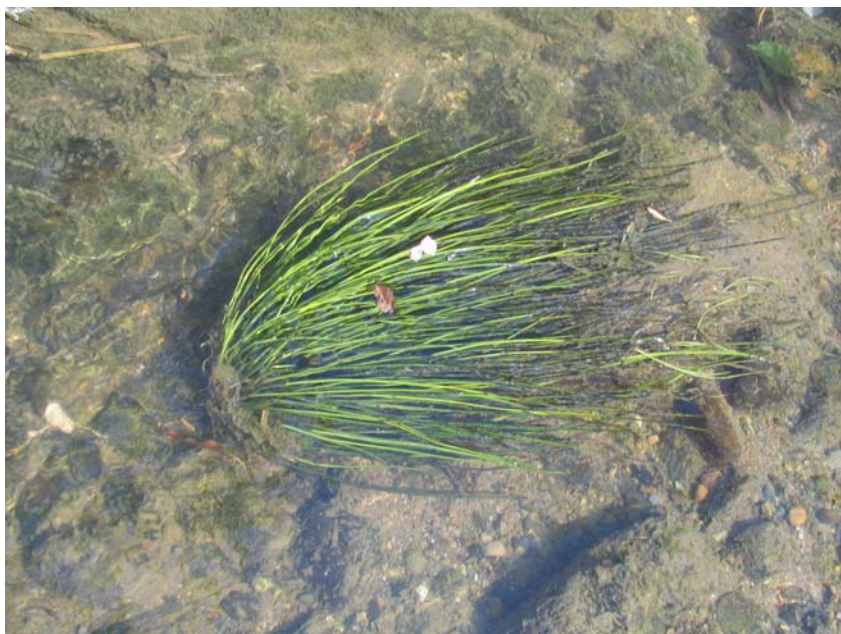
Plate 3

Plate 3. The stocks that are almost washed away. Roots are loosened from the bed of a river. A and B: April 4, 2005, ca. 10m upstream Site 1 at Higashikanda River.

It seems that the root growth is critical to the establishment of the plant on the river (Plate 3). The patterns of gemmae distribution are nearly random and much more widespread than the old plants. This means that many gemmae have rooted on the areas in which plants are easily washed away. This also suggests that gemmae are more likely to be affected by the stream flows than the old plants. The rate of successful rooting is extremely low, except the vicinities of mother plants or slow flows.

These cultivated plants have to be replanted to the river habitats. Here the rooting of the cultivated plant becomes a key to the successful conservation (see Plate 3). There are almost no rooting places on the flat river floors of these rivers. We should prepare the rooting place on the river floors. River floors are mostly made of concrete or natural silt layer, either of them cannot support roots. We may drill a hole to the floor and place the root through these flat floors. We may also modify the river flows from straight to winding as in natural rivers to reduce the flow velocity during floods. These protective measures on the river structure may be also applied to the natural plants. The secure rooting is the key to the conservation of this species. With these conservation and management measures, we may save this very rare endemic aquatic plant from extinction.
